Pipeline and Hazardous Materials Safety Administration
Office of Hazardous Materials Enforcement
Central Region

*Separating Fact from
Fiction Orientation Course
Bloomington, IL*

Ag Retailer Compliance

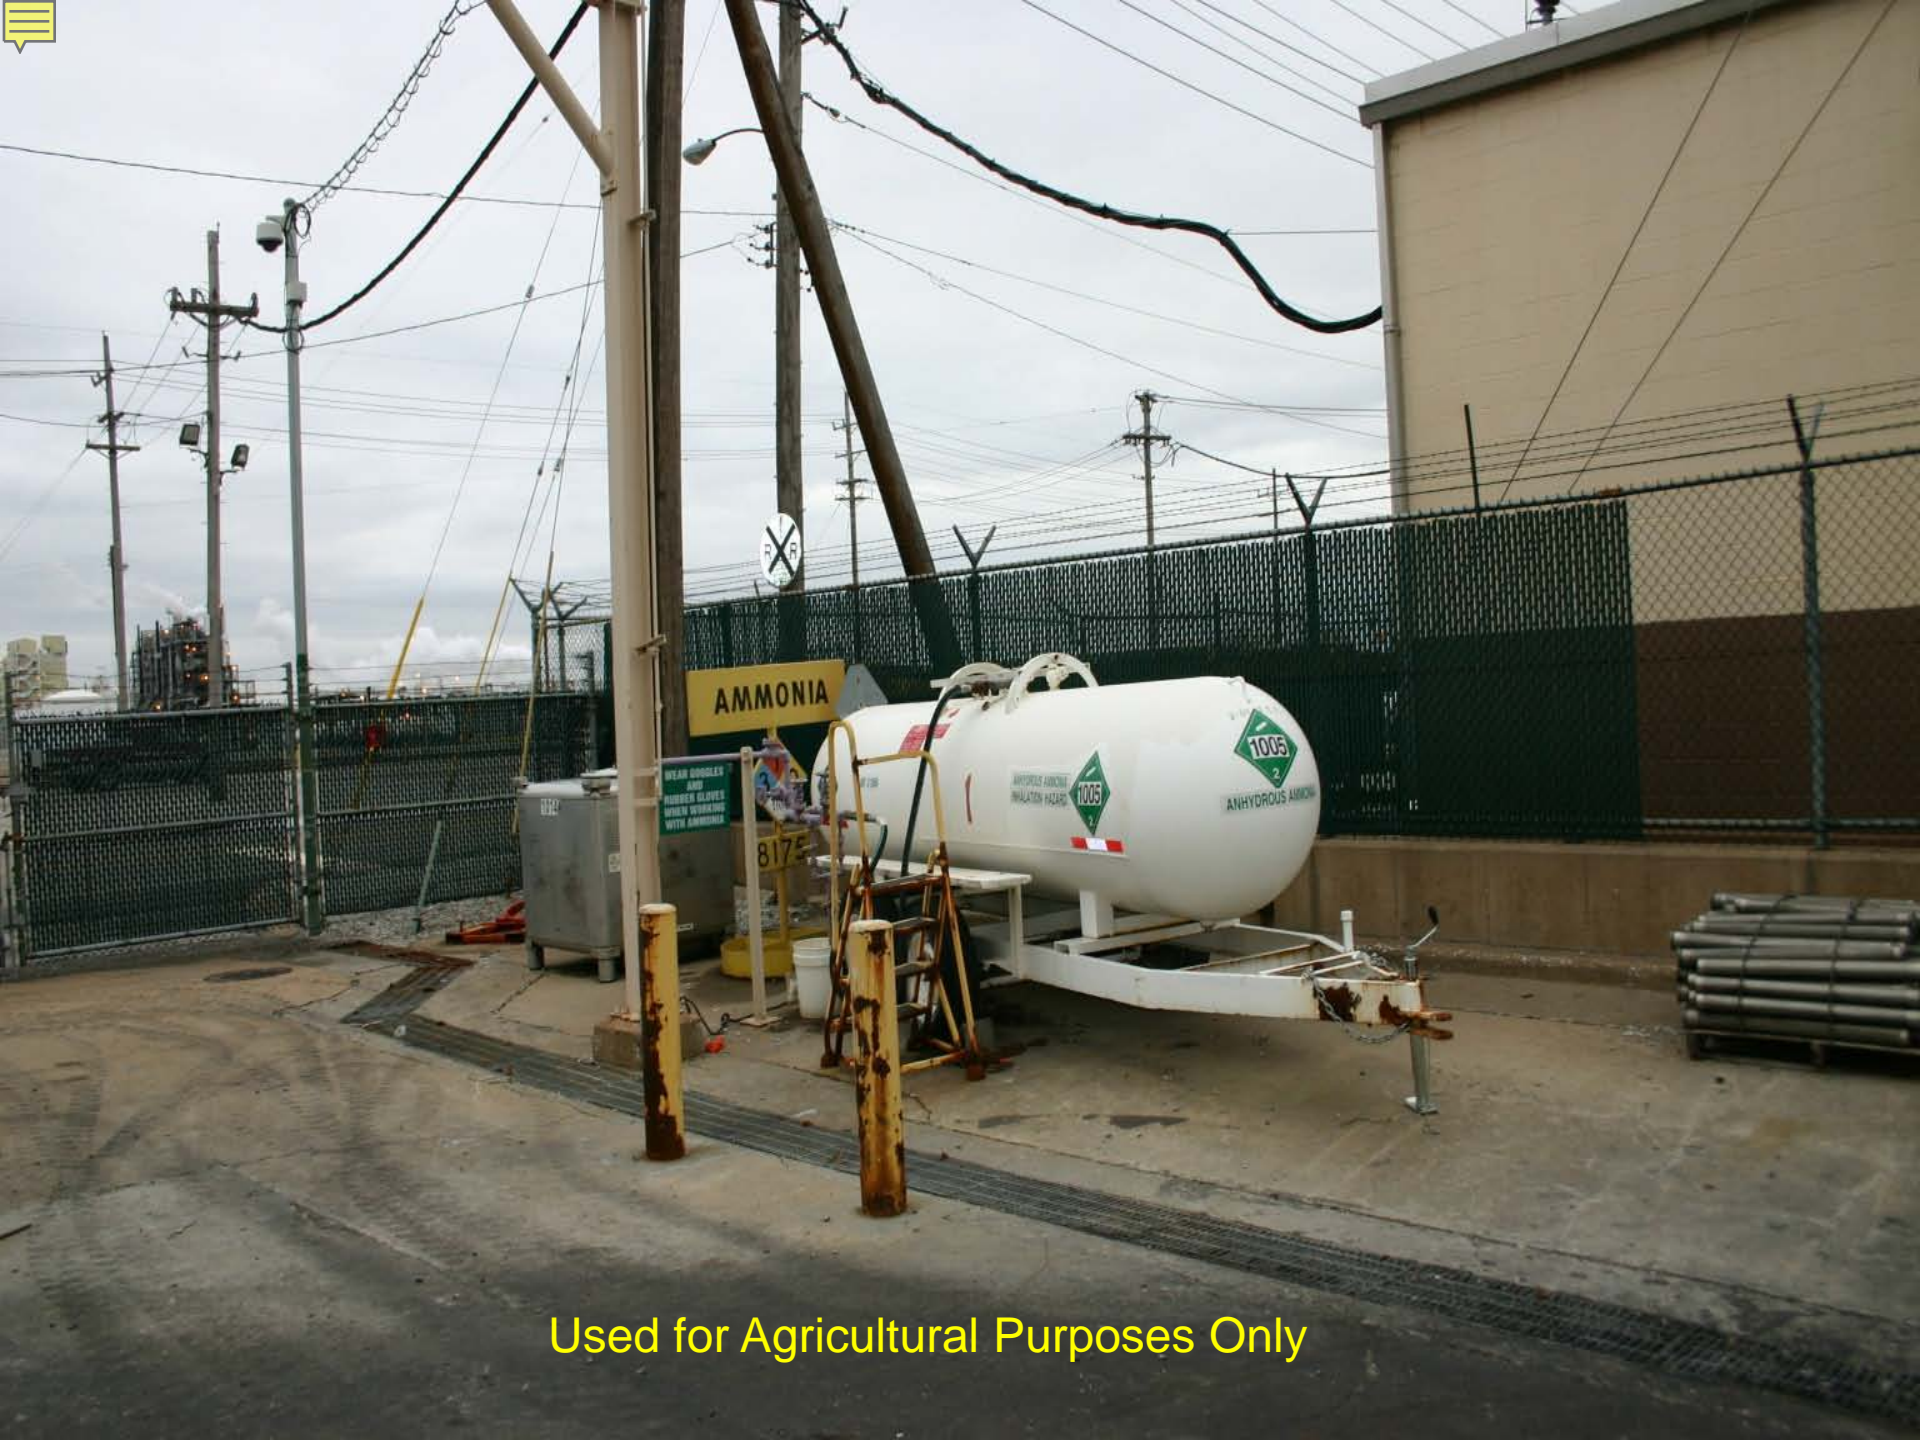
AMMONIA

WEAR GOGGLES
AND
RUBBER GLOVES
WHEN WORKING
WITH AMMONIA

1005
ANHYDROUS AMMONIA
INHALATION HAZARD

Used for Agricultural Purposes Only

Used for Ammonia Service Only

ASME Code Tank and Is Marked Accordingly

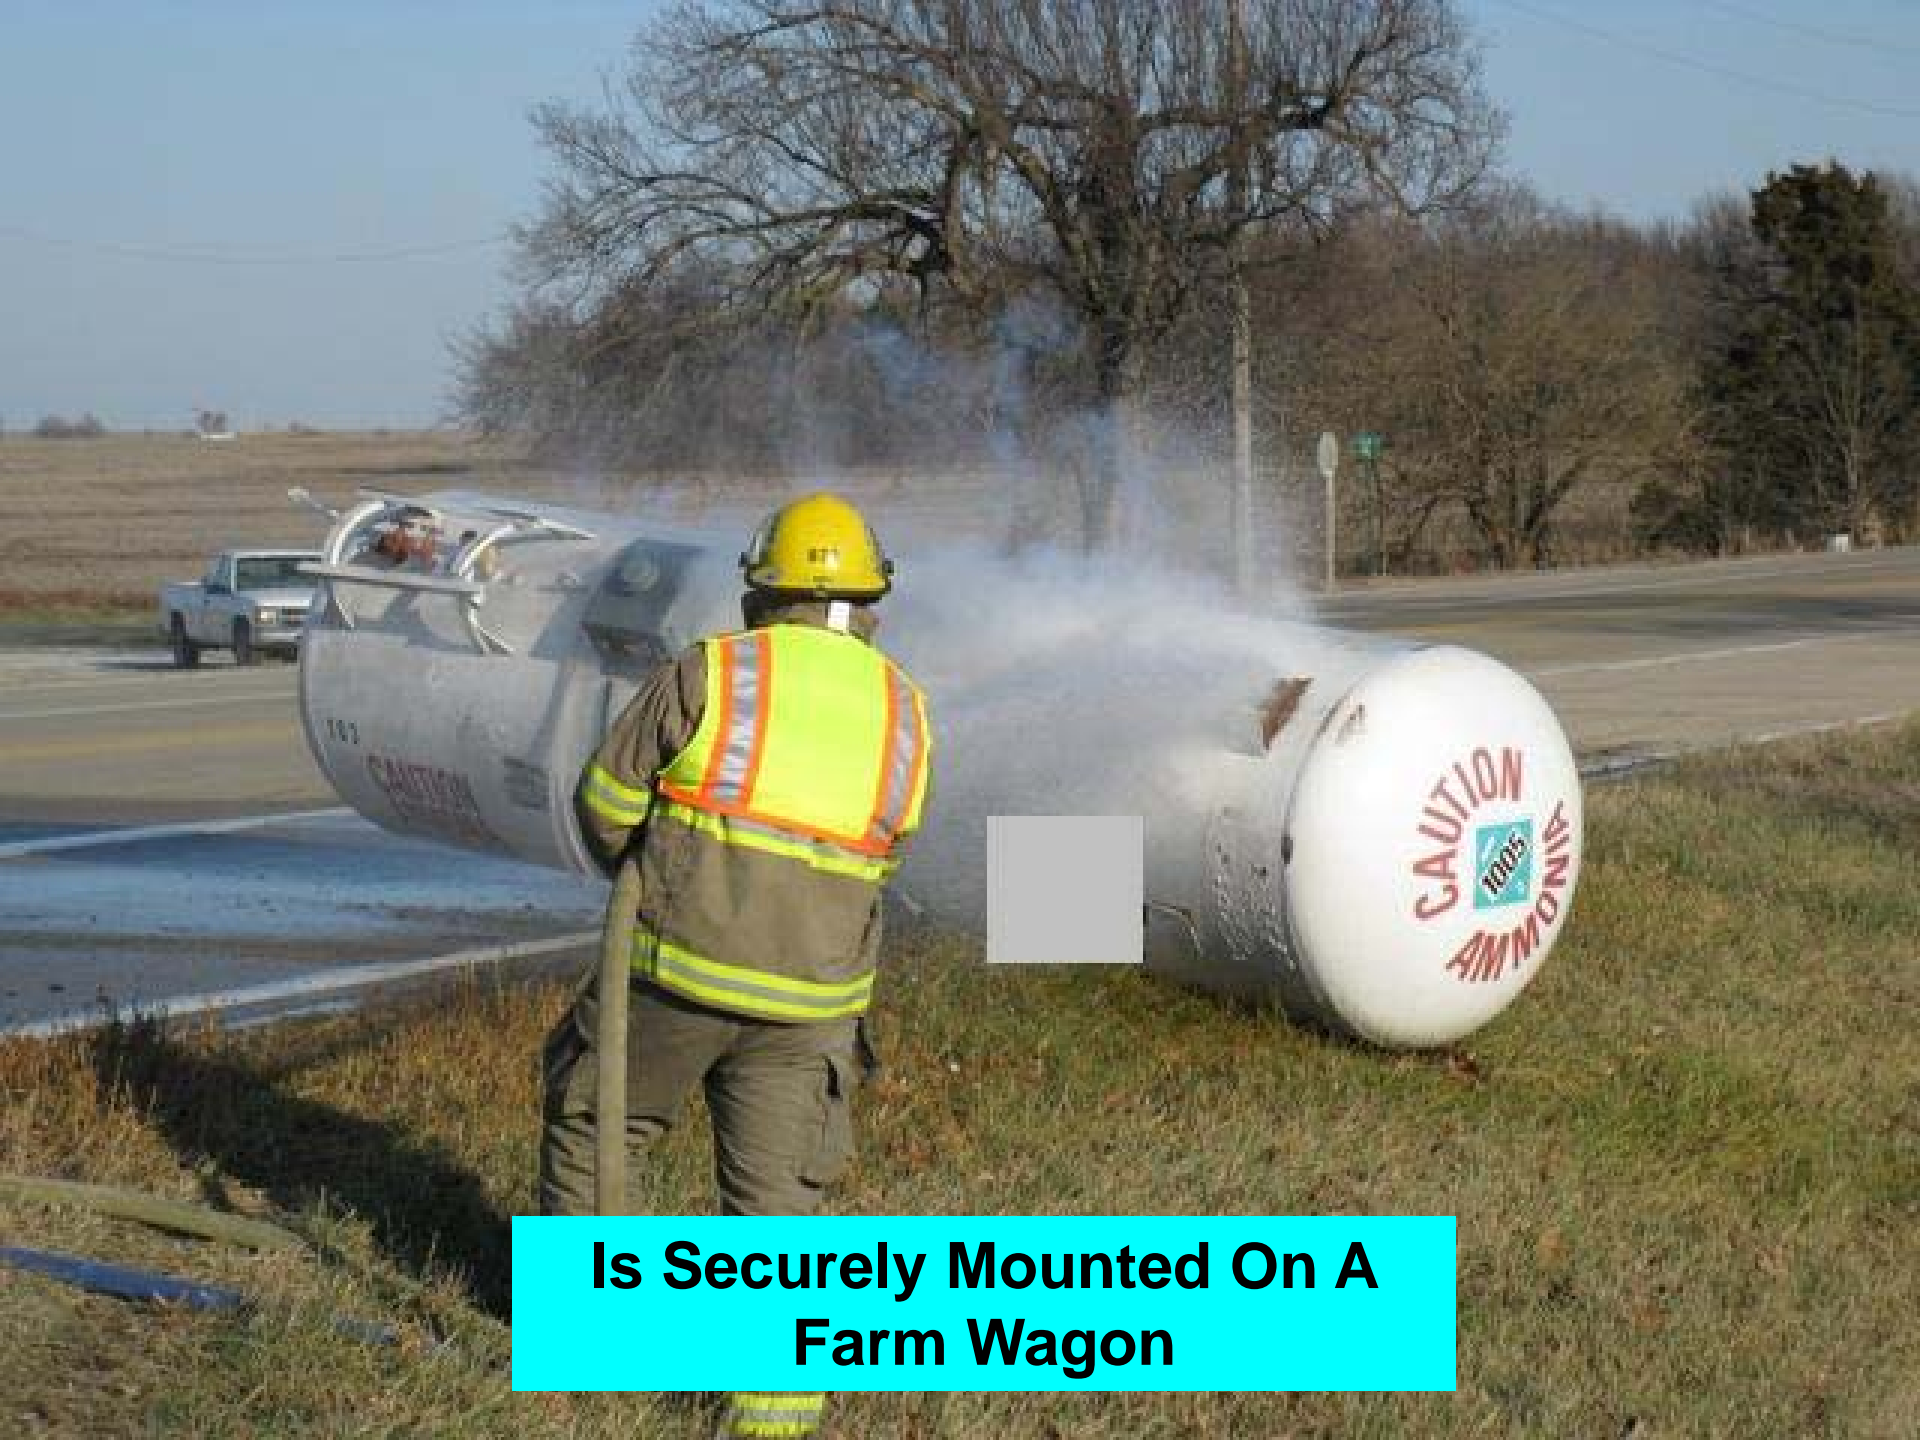
Is Securely Mounted On A Farm Wagon

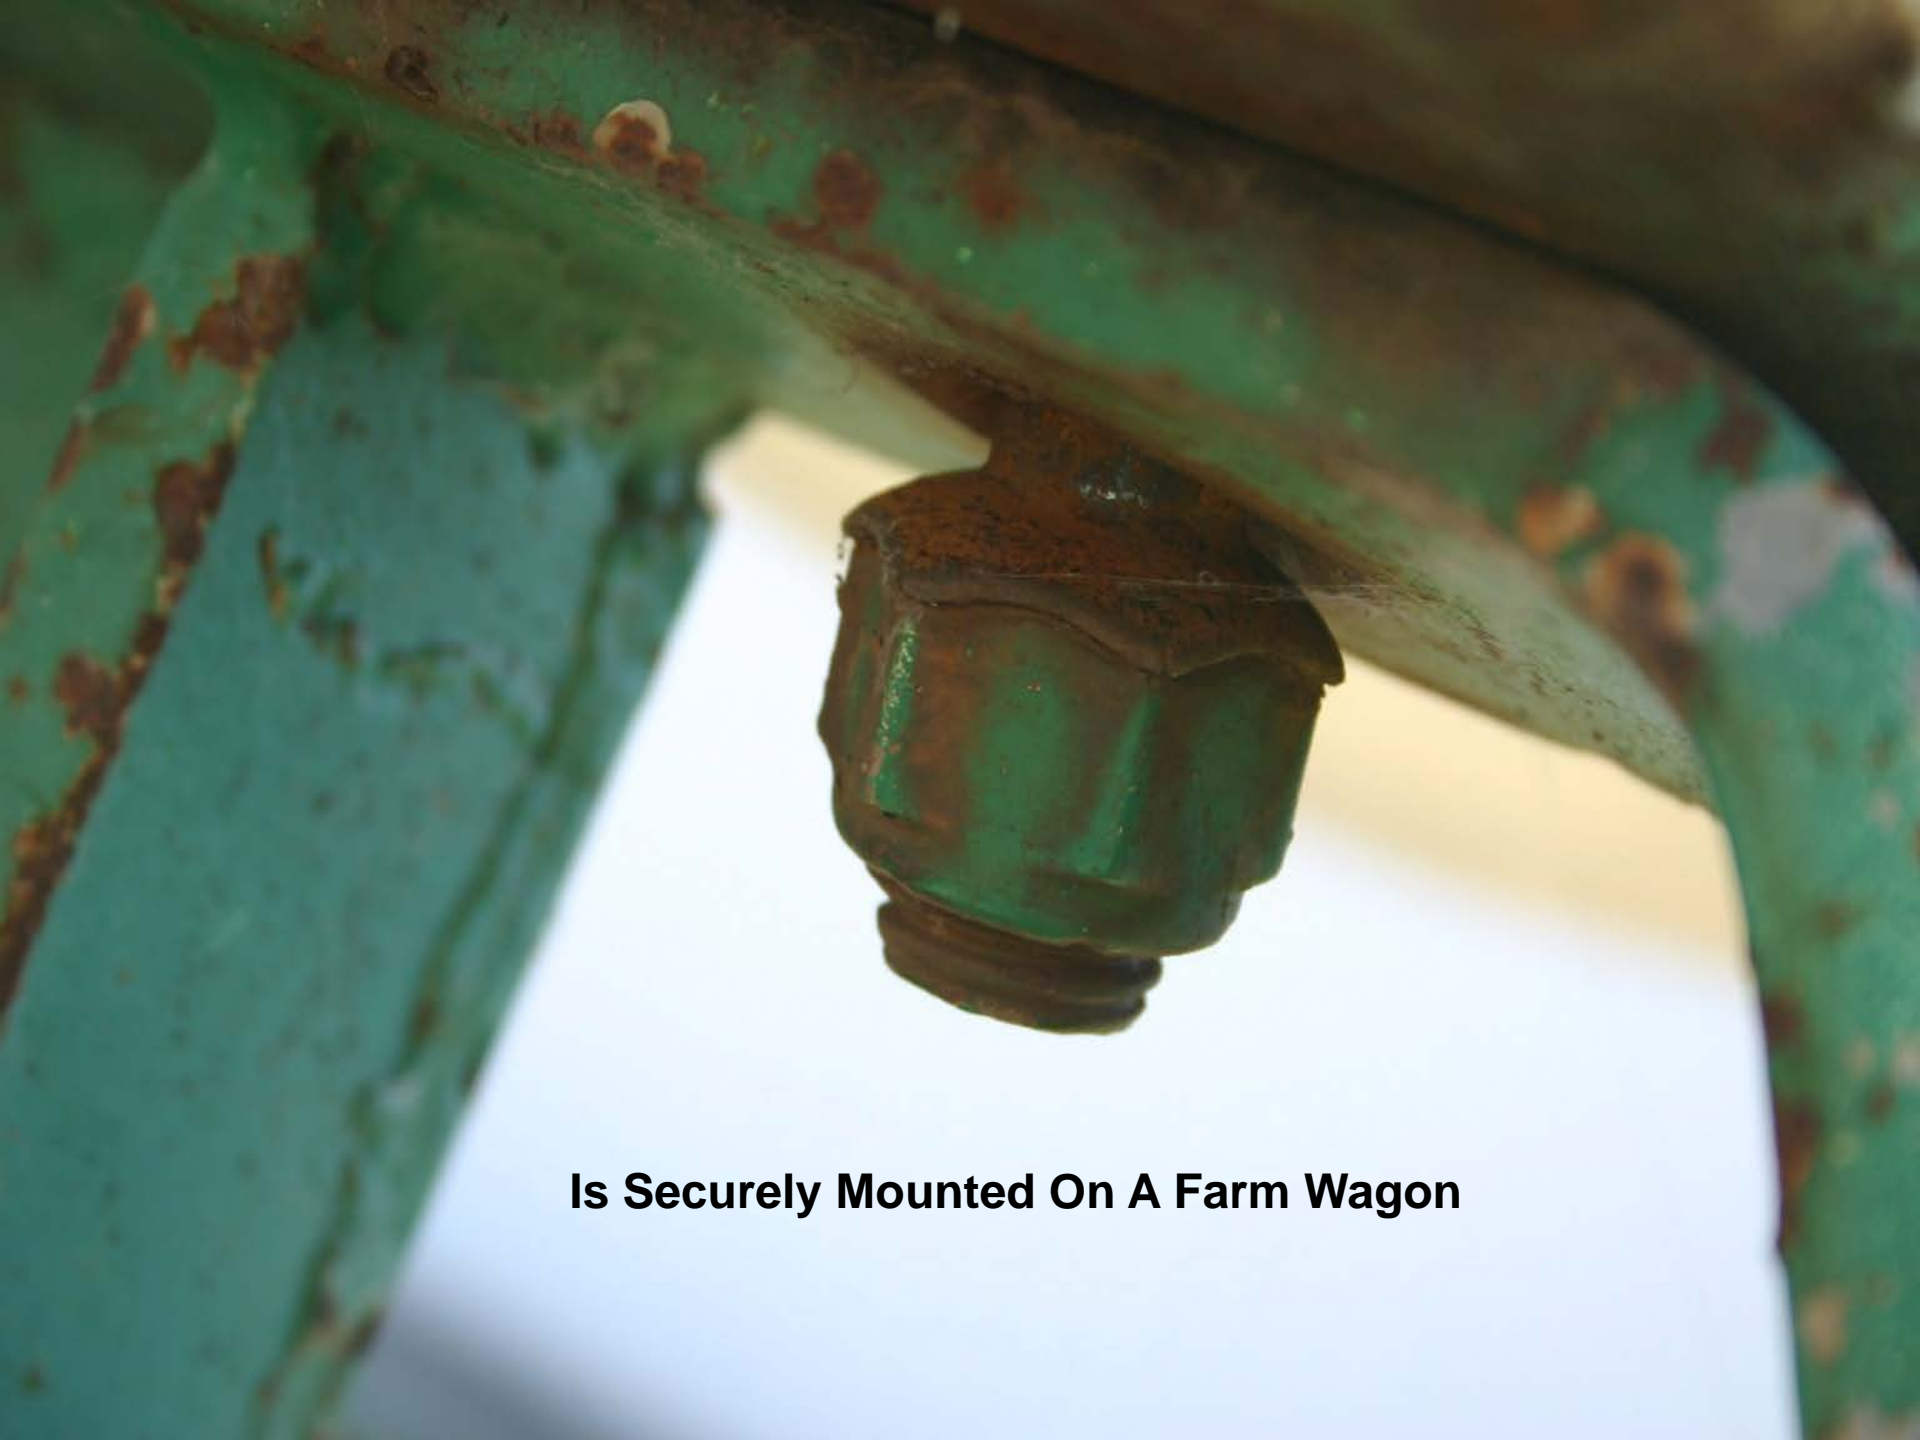
Is Securely Mounted On A Farm Wagon

A close-up photograph of a metal bolt and nut assembly. The bolt is threaded and passes through a hole in a metal plate. A hexagonal nut is tightened onto the bolt. The metal surface is heavily rusted and shows signs of wear. The background is blurred, suggesting an outdoor setting.

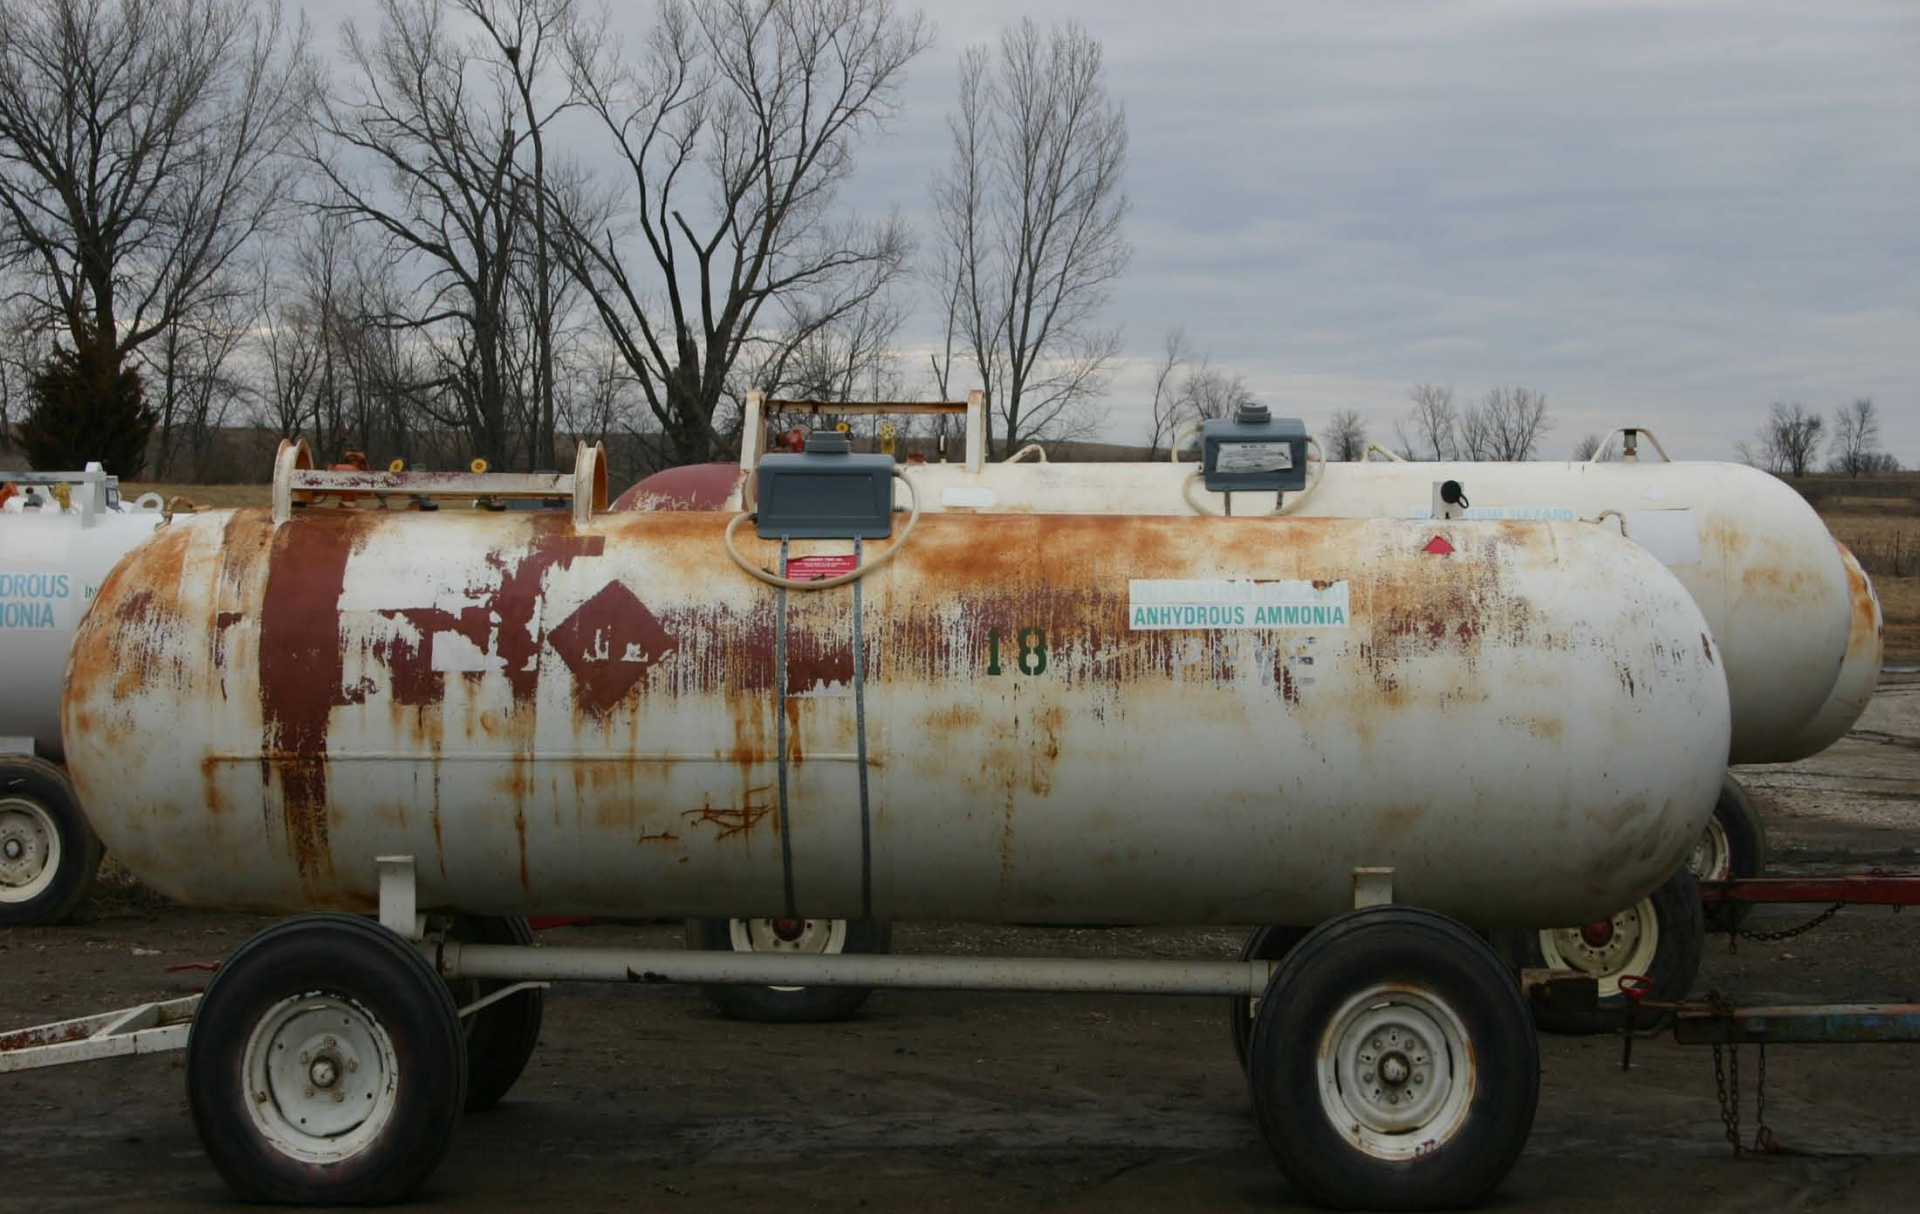
Placarding and/or Marking

Make Sure Your Placard Is 273 mm In Size

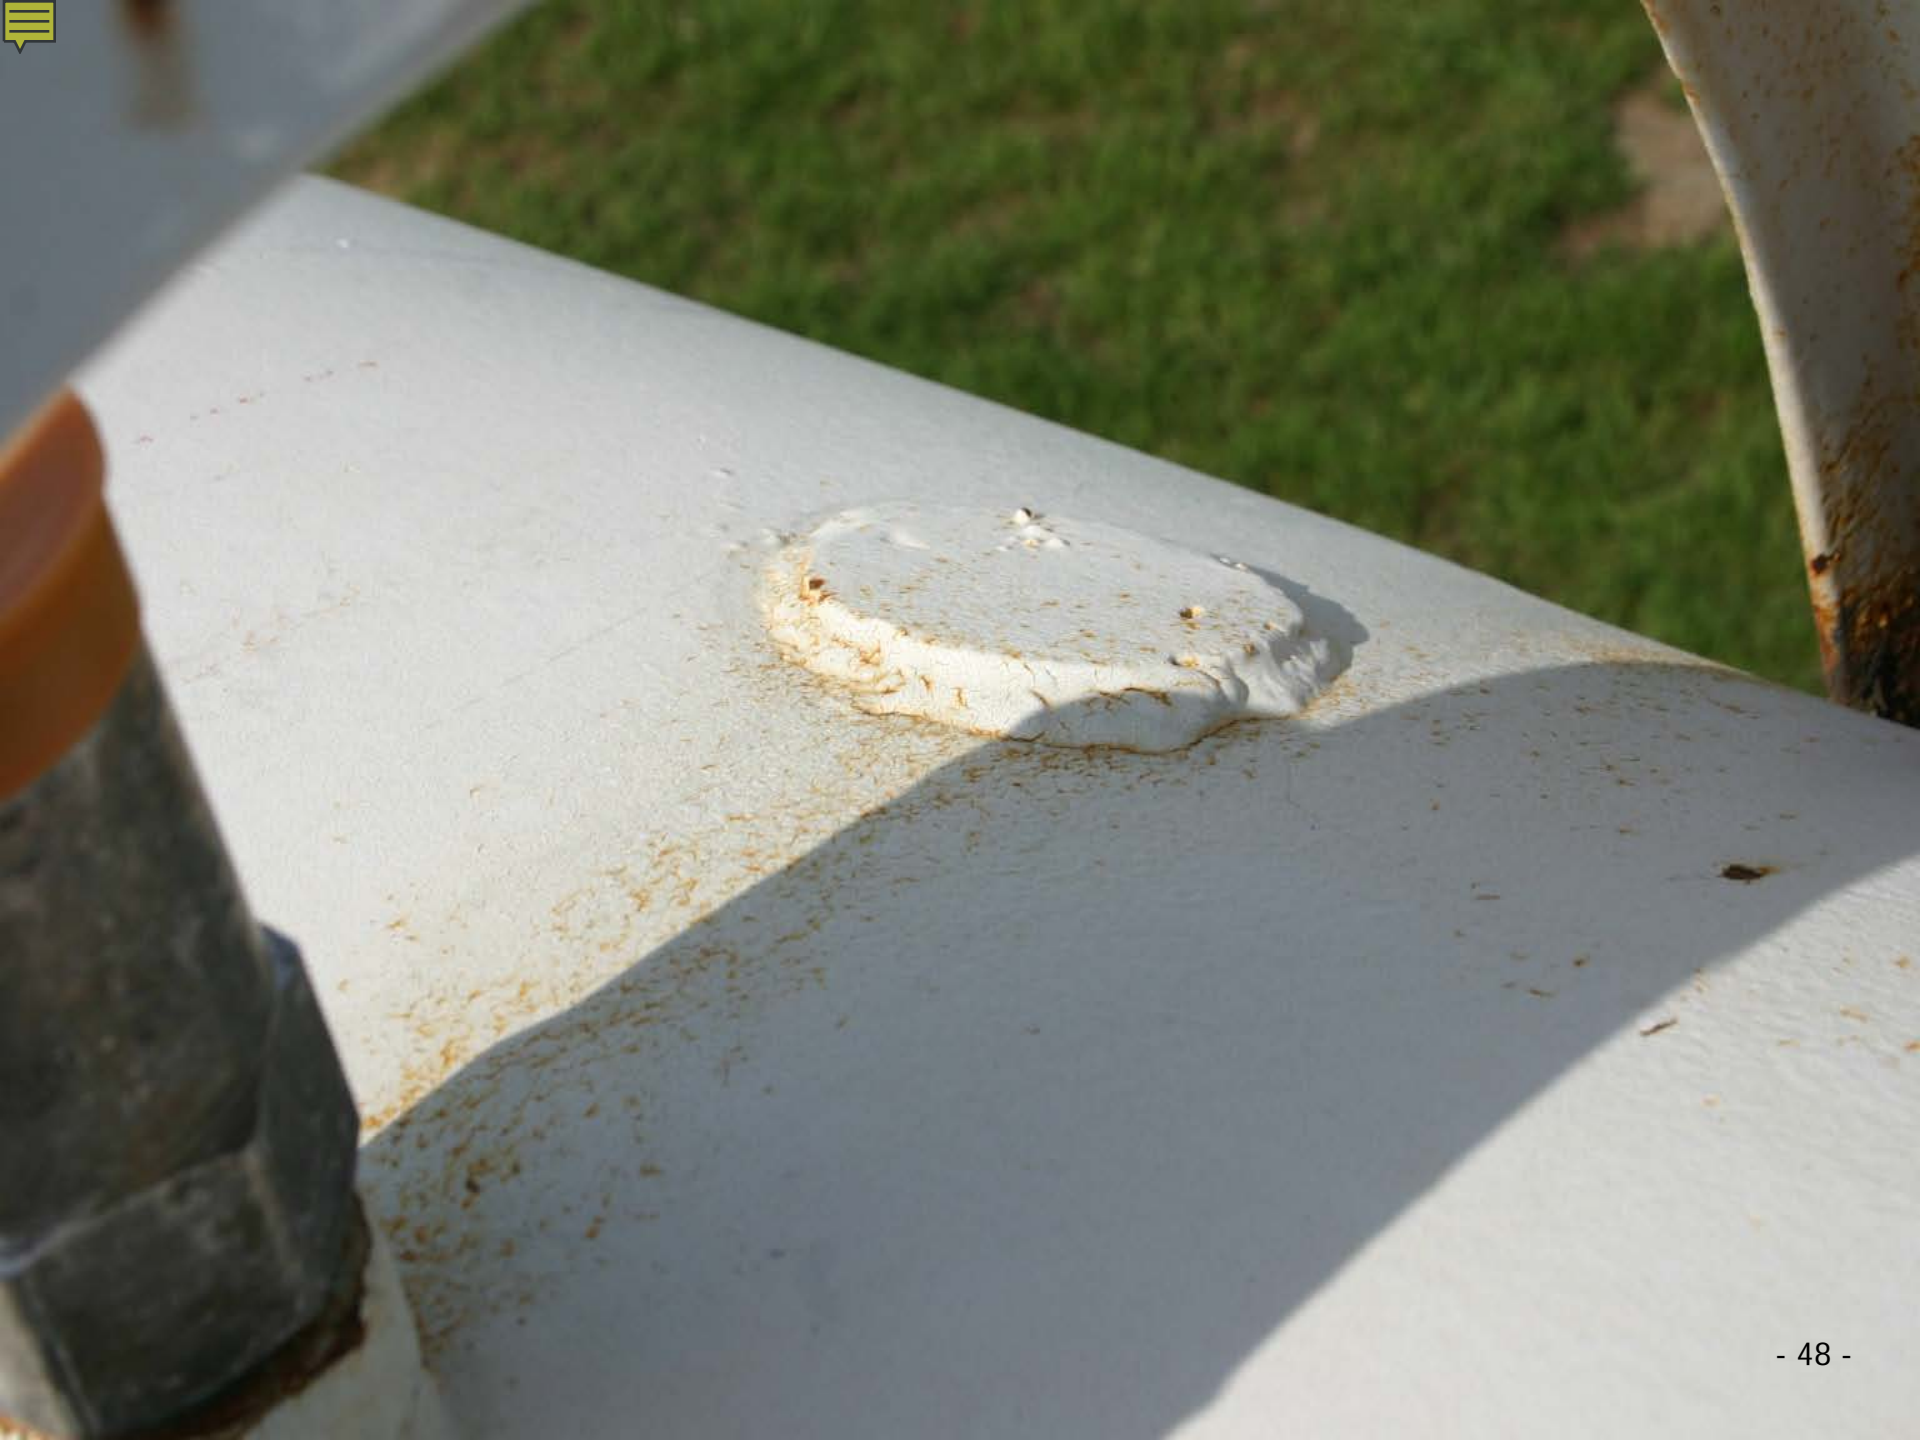
Note the differences in the thicknesses of the tank material and the patch

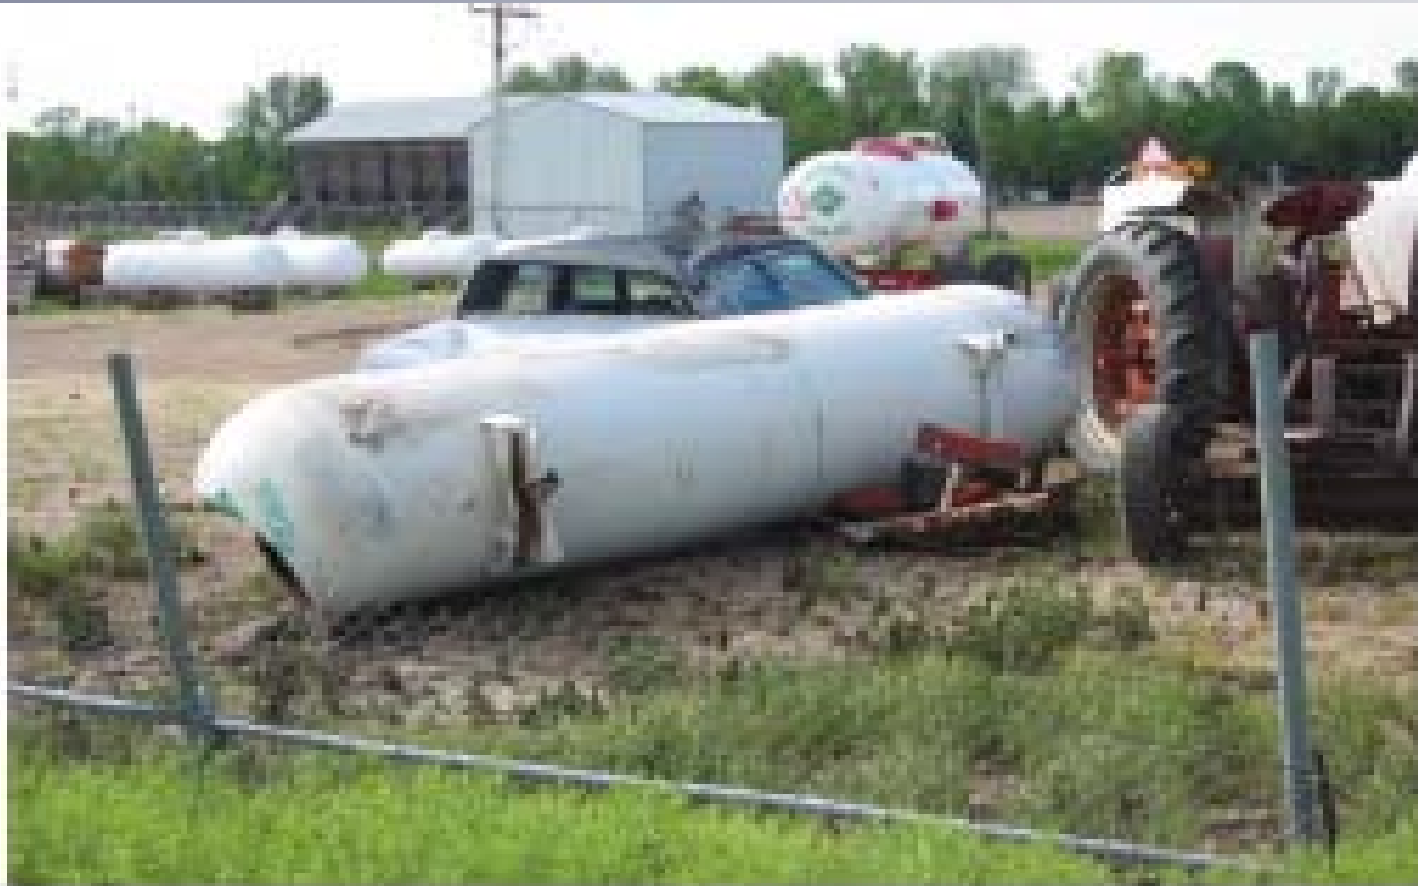
Calamas Iowa accident April 2003.

Tank was loaded, the driver was hooking the tank up to a pickup, tank ruptured for no apparent reason. This rupture caused one fatality and one very serious injury.

The arrow shows the location of the tank at the time of the rupture and the hole that was blown in the ground as the result of the release of the gas.

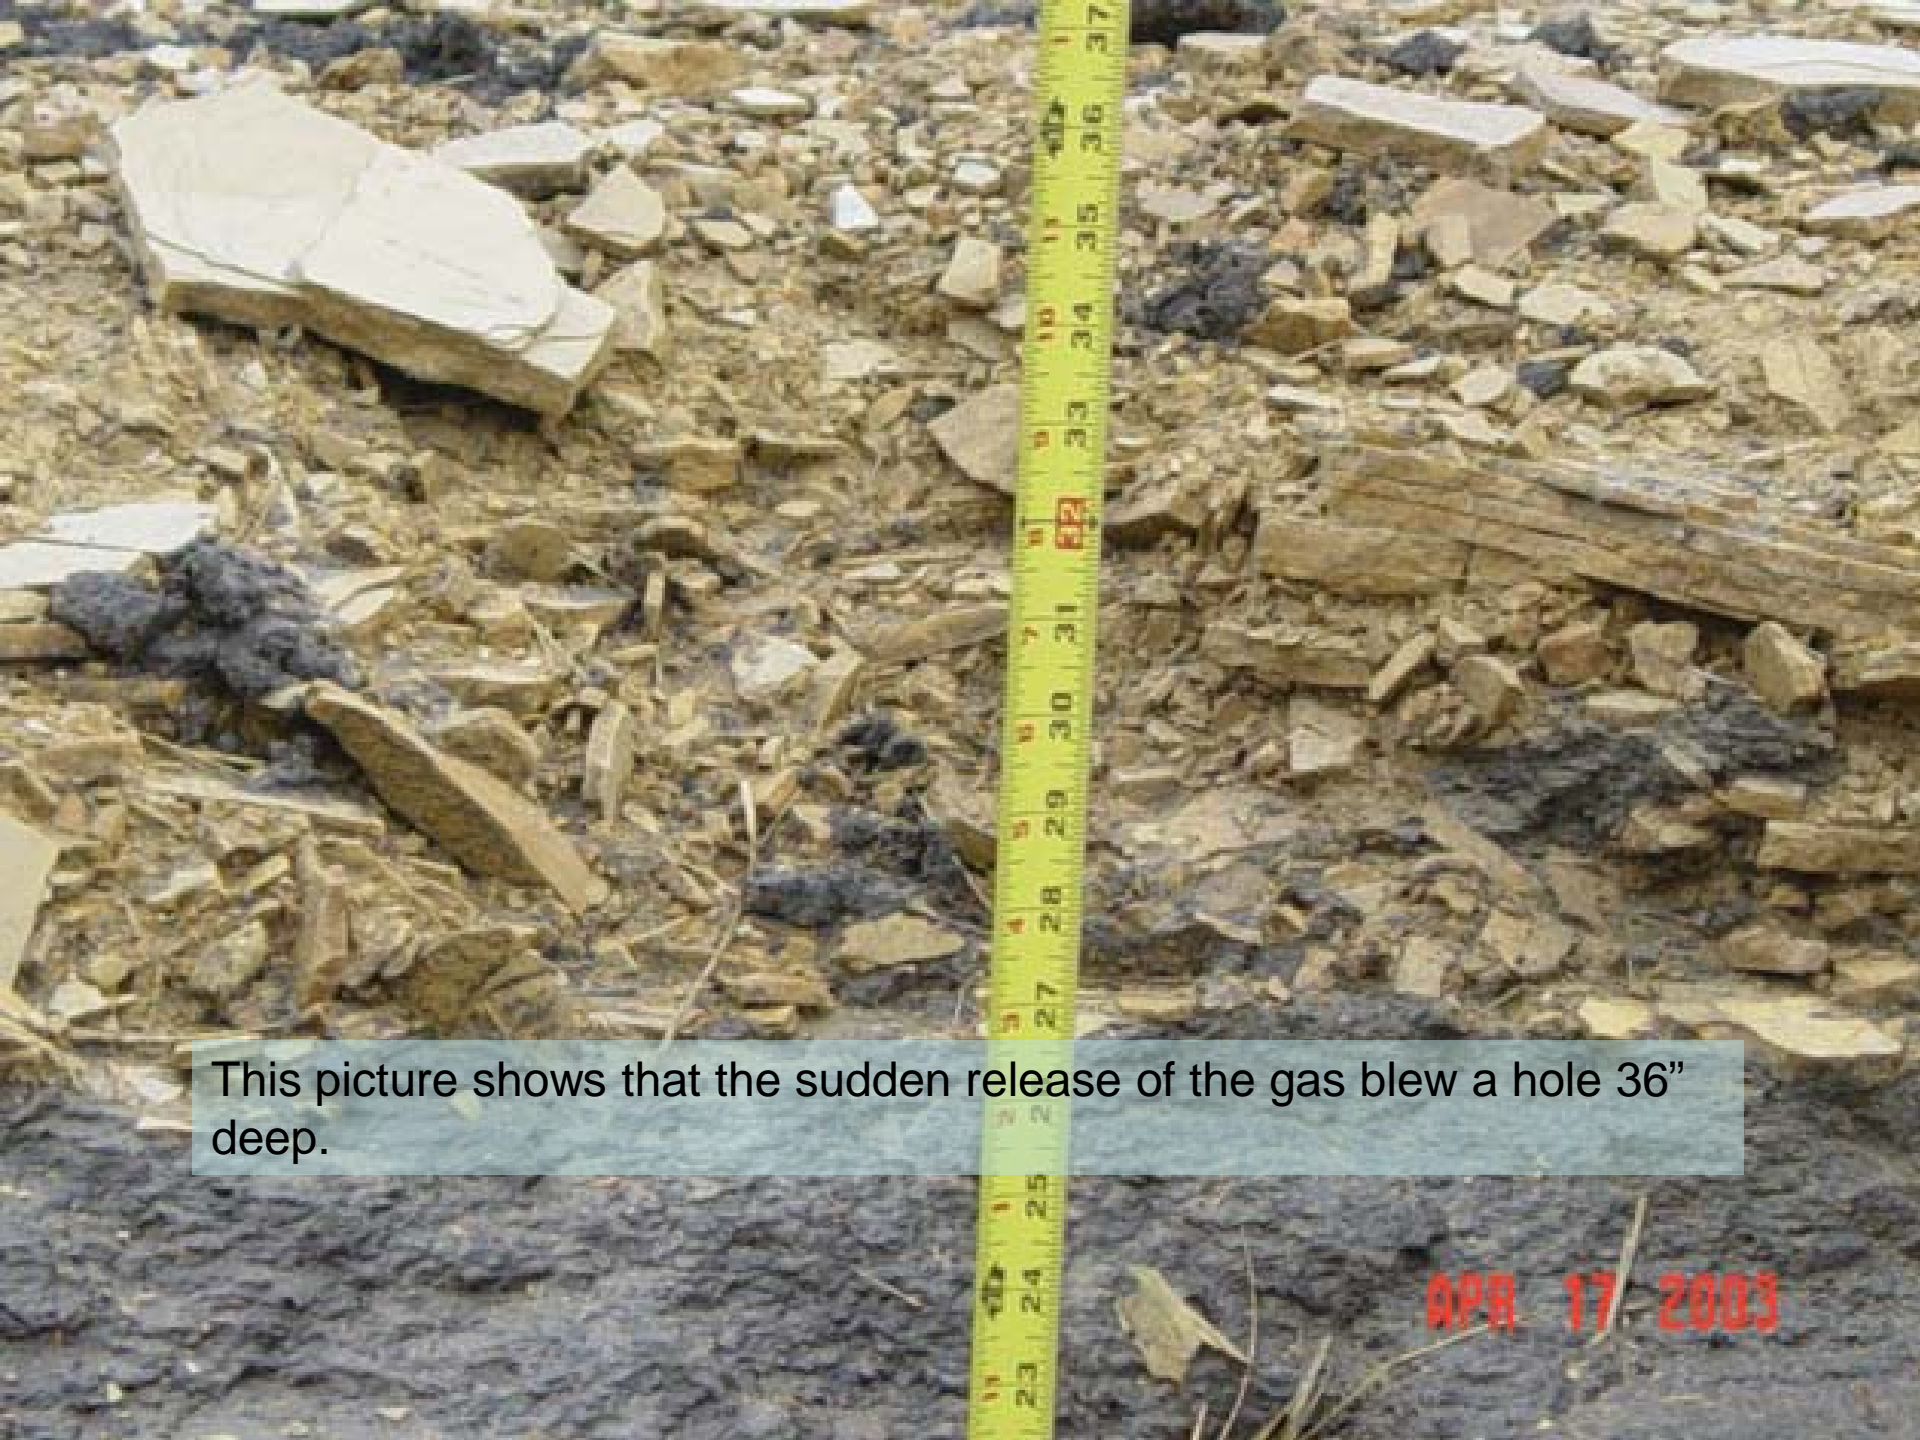
This picture shows that the sudden release of the gas blew a hole 36" deep.

The total length of the opening is approximately 4'6"

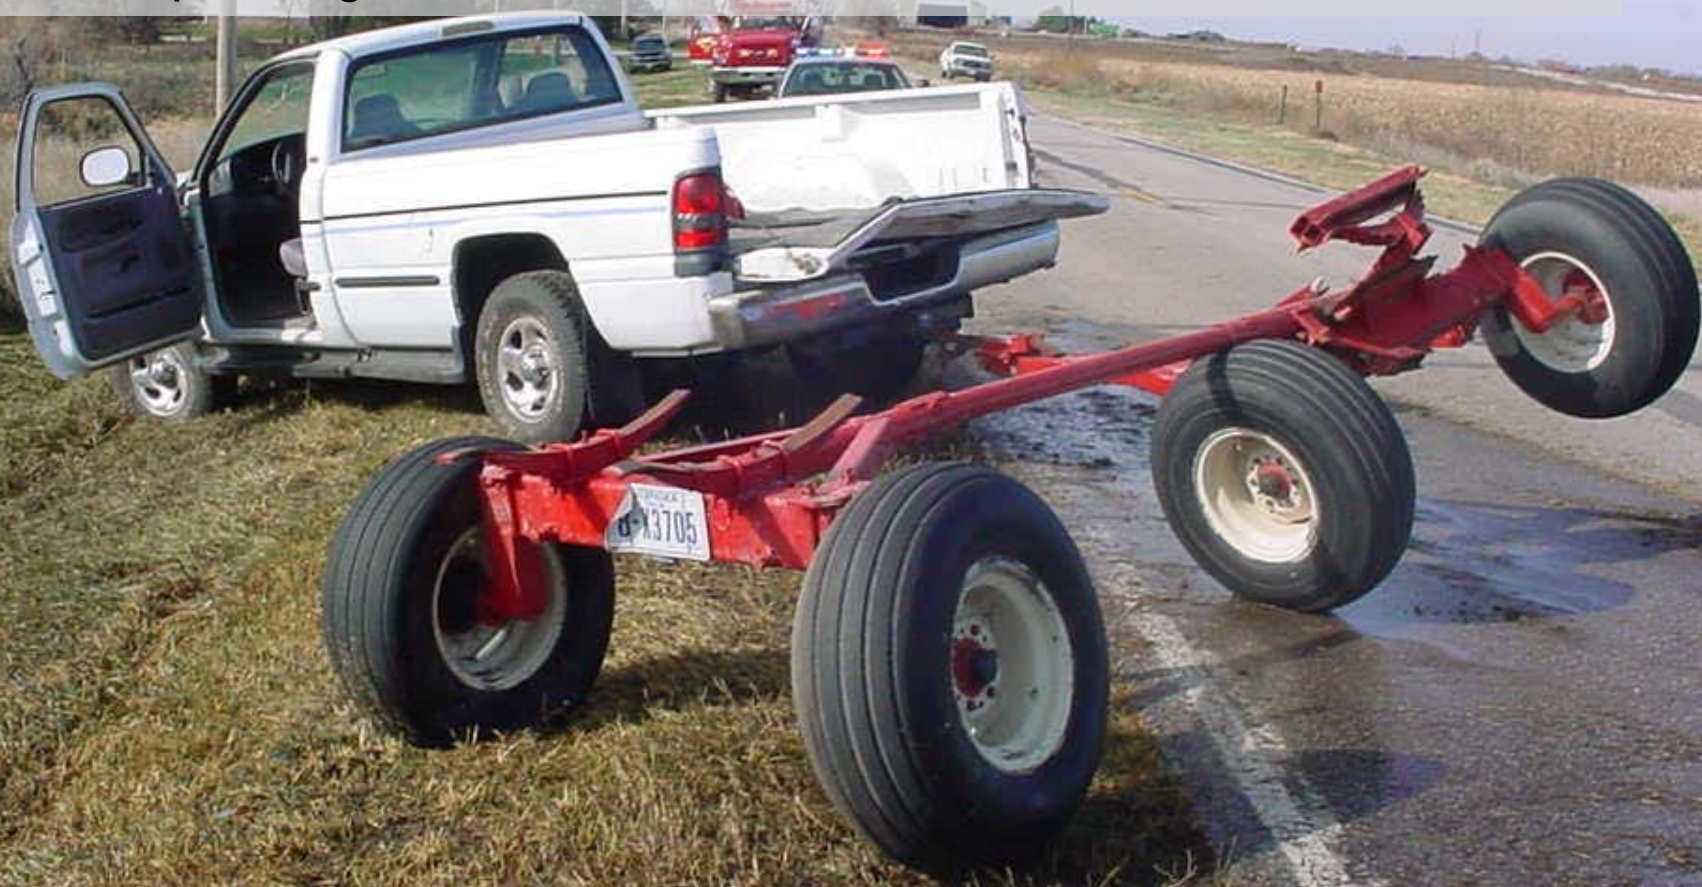
Tank did not have a ASME nameplate, and passed an external visual inspection just a few days prior to the incident

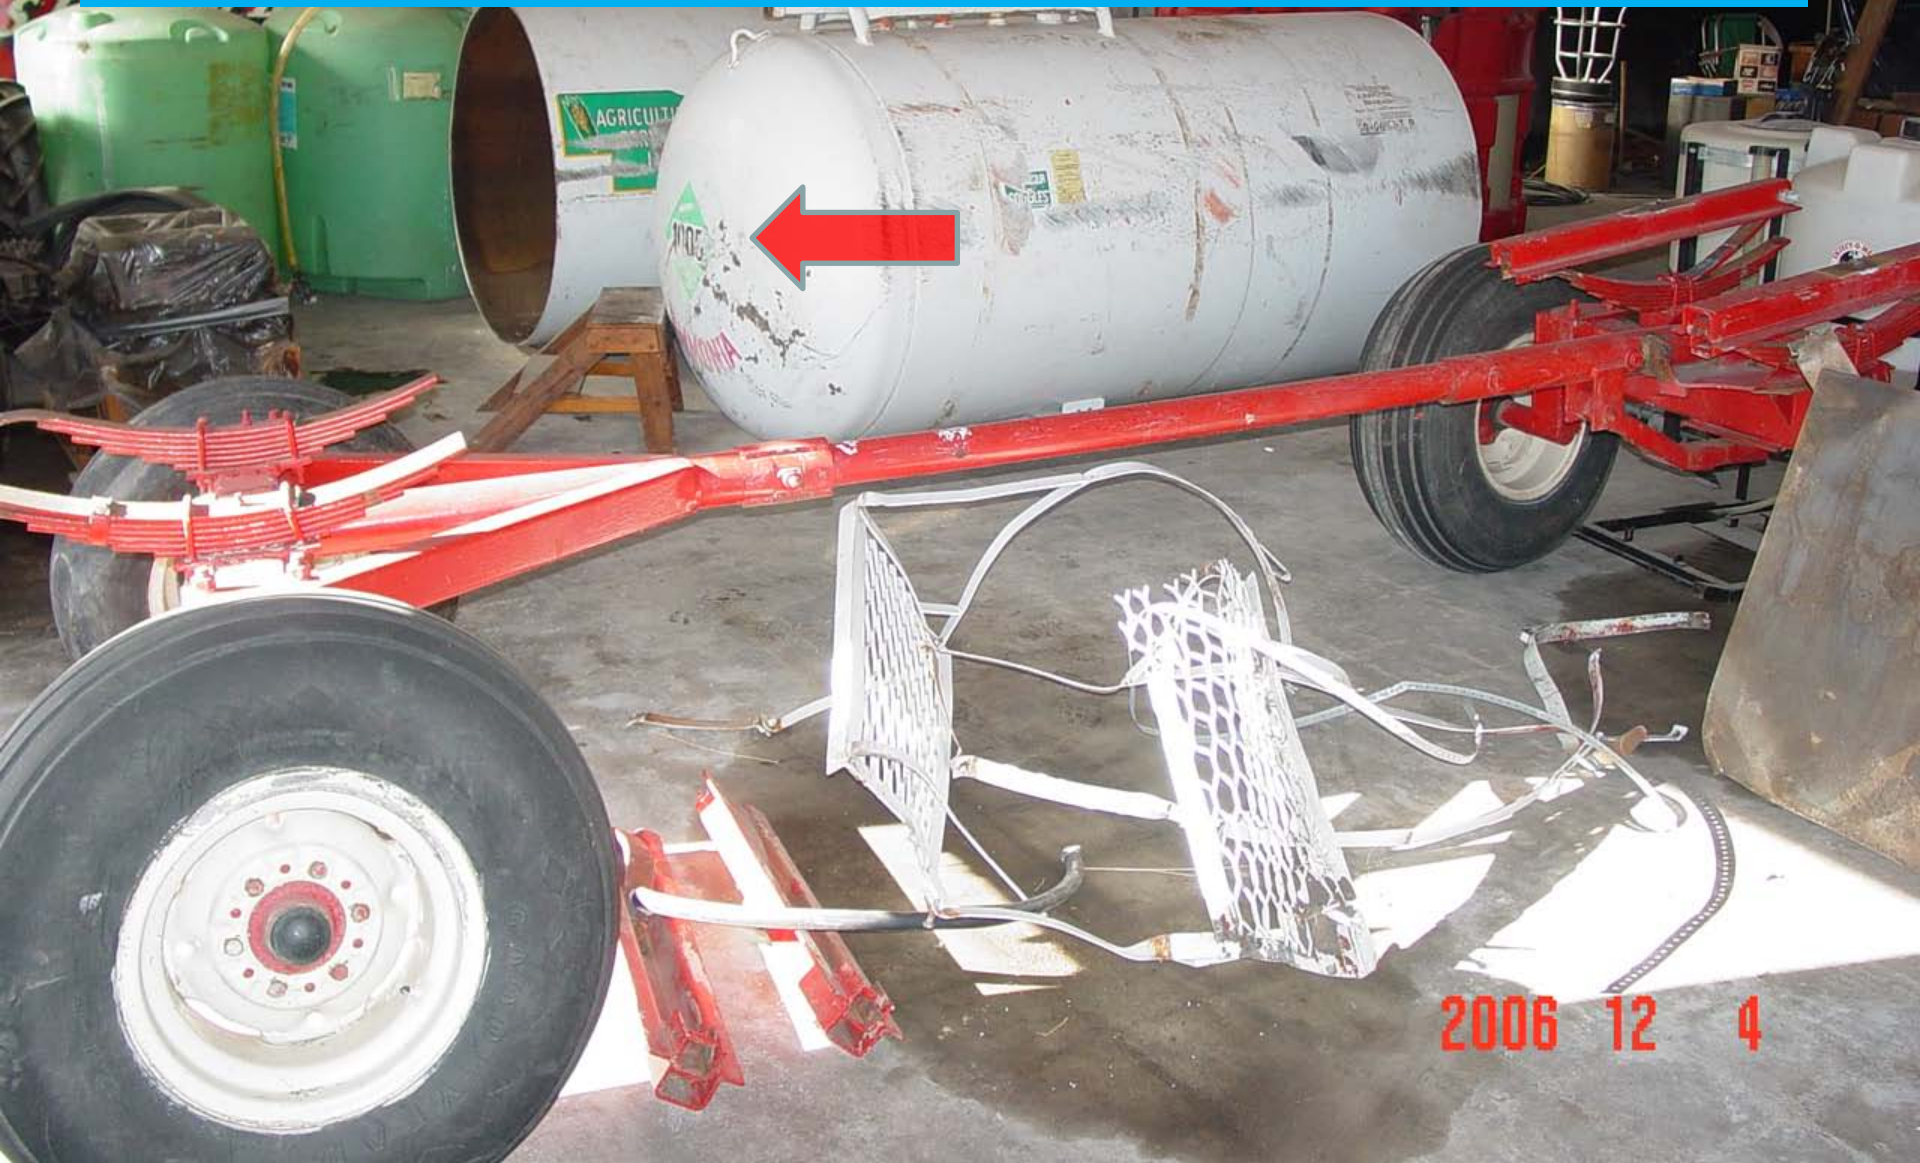
Tank failed hydrostatic testing in Canada
